Re: Edna G Tugboat Relocation Options

AMI Project # 181014

This letter is written in regard to the progress of the feasibility study of the relocation of the Edna G. Tugboat which is currently located in Agate Bay in Two Harbors, MN. The purpose of the work is to determine the feasibility of relocating the Edna G Tugboat to a location out of the water for the long-term preservation of the vessel.

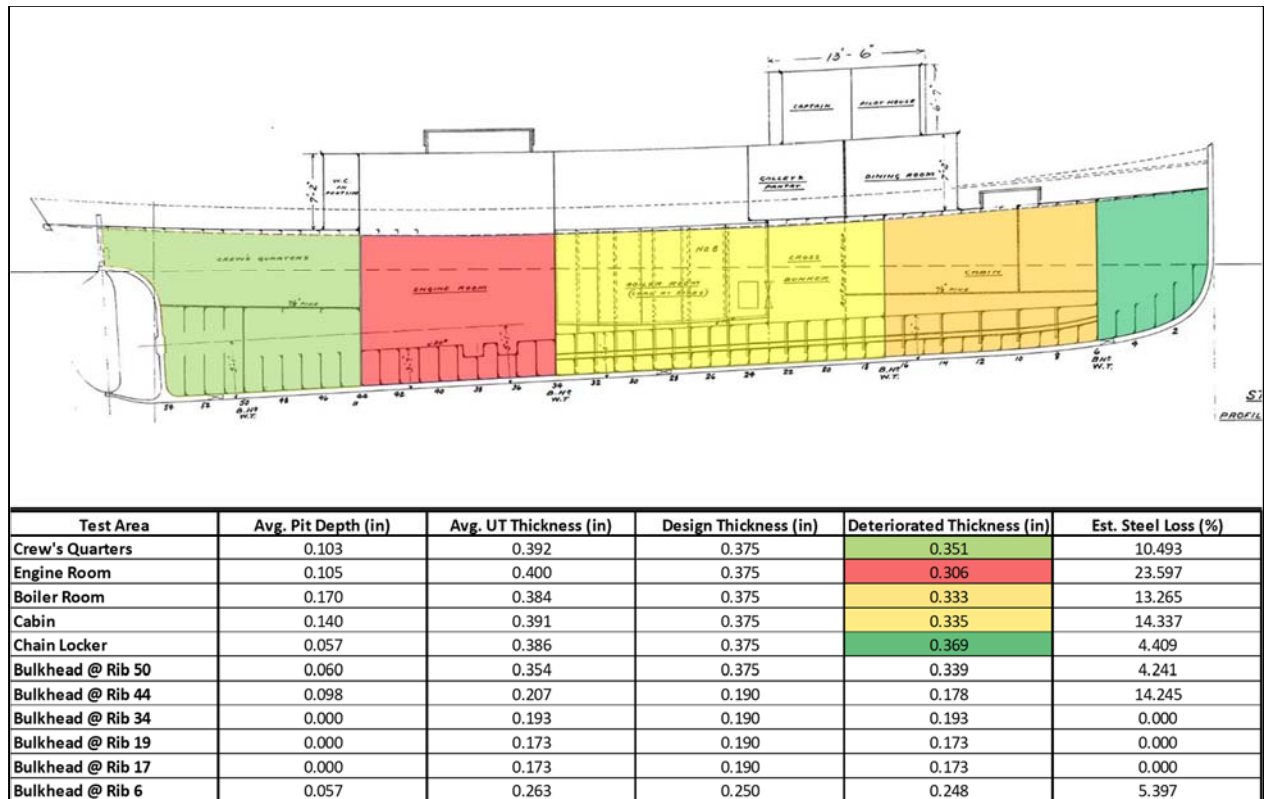
Image 1: Summary of Hull and Bulkhead Condition Data from Site Inspection 1

Historical drawings of the vessel were used for reference. It may be noted that the average UT readings were greater than the original design thickness. This is most likely due to manufacturing process and quality control practices of fabricating steel plates in the late 1800's. The thickness of the hull coating likely did not affect the UT measurements since consistent results were documented in the coated & uncoated areas of the hull. During the inspection, AMI also estimated the concentration of the pitting due to corrosion. The deteriorated steel thickness was determined from a weighted average of the steel loss due to the corrosion and the concretion of the pits.

The condition assessment findings were consistent with results from a previous assessment performed in 2013 by AMI. The interior coatings were found to be mostly intact and have prevented further deterioration of the vessel. Preliminary, it appears that the vessel could be moved or towed to another location in the water without damaging the hull. It is standard procedure to lock the rudder and screw of the towed vessel in position, to prevent any torque from being transmitted to the engine and/or jacking gear.

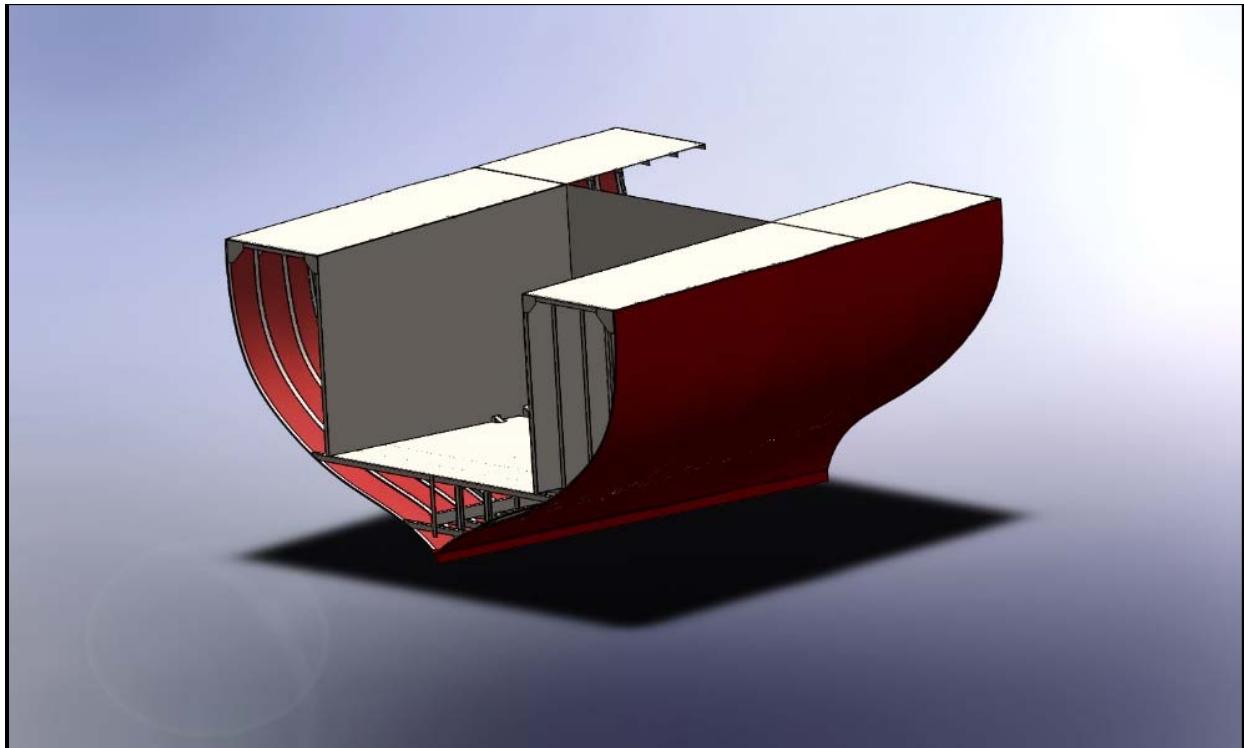
A model of a cross section of the Edna G has also been completed so Finite Element Analysis (FEA) could be completed. The FEA will be utilized to determine the effects of lifting the vessel from the water and potentially setting it on a cradle. The most significant deterioration was observed in the ship's Engine and Boiler Room. These sections also support the heaviest loads, so supporting this area is a concern. Placing one of the support cradles at this bulkhead (located at the 34th rib of the vessel) seems logical, if the vessel is to be placed permanently on land. Rib locations can be seen in the attached, original drawing of the vessel.

Image 2: Cross Section Model of Edna G. Tugboat
